Manhole Inspection Summary

Manhole # S19G__001MH

Insp Date: **4/24/09 2:22 PM**

Location Address: **2245 LEXINGTON-VINE**

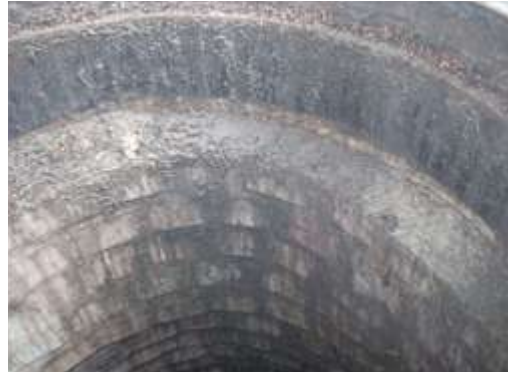
Defect 2

Infiltration: ☐ None ☒ **Joint** ☐ Cracks ☐ Mortar ☐ Roots ☐ Wall

INFILTRATION OF THE JOINT

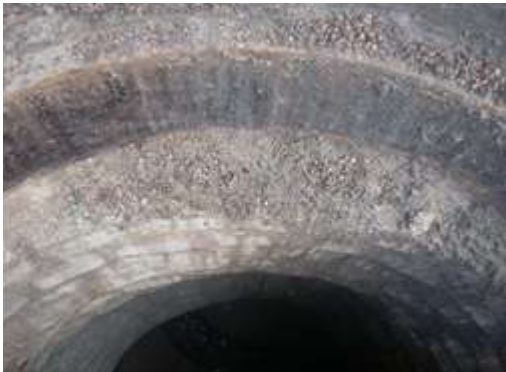
Defect 1

Frame Offset: **2** (in.) Condition: ☒ Sound ☐ Cracked ☐ Leaks

FRAME OFFSET

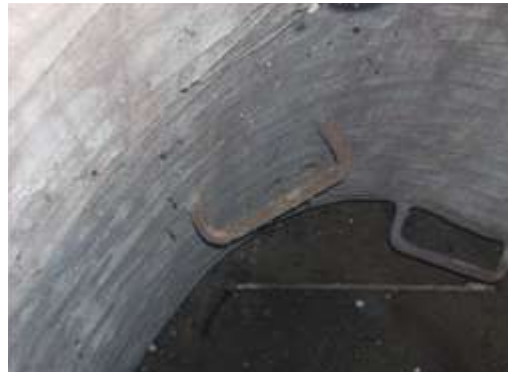
Defect 3

Steps Count: **4** Missing: **0** ☒ **Corroded**

CORRODED STEP

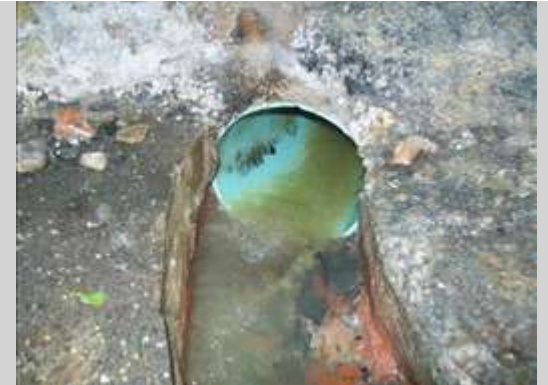
12 O'Clock Outflow

8 in. Circular Gravity Sewer
Pipe Out @ 12 O'Clock

Pipe Height: **8.4** (in.) Rod and Bar (Angled)
Pipe Material: **PVC** ☐ Pipe Lined
Invert Depth: **9.38** (ft.) Flow Characteristics: **Slow**
Deposits: ☒ None ☐ Mud ☐ Sludge ☐ Debris ☐ Grease
Silt Depth: (in.) Deposits Extent:
Infiltration: **None** Pipe Seal Cond: **Sound**

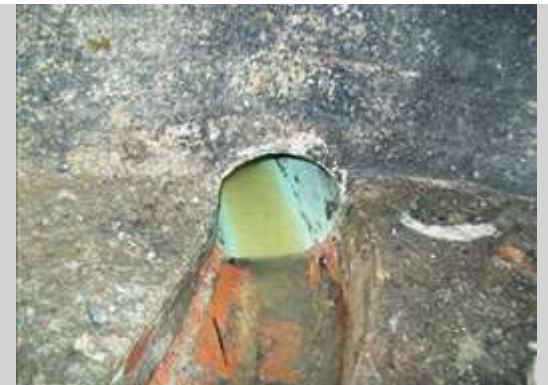
3 O'Clock Inflow

8 in. Circular Gravity Sewer
Pipe In @ 3 O'Clock

Pipe Height: **8.4** (in.) Rod and Bar (Angled)
Pipe Material: **PVC** ☐ Pipe Lined
Invert Depth: **9.12** (ft.) Flow Characteristics: **Slow**
Deposits: ☒ None ☐ Mud ☐ Sludge ☐ Debris ☐ Grease
Silt Depth: (in.) Deposits Extent:
Infiltration: **None** Pipe Seal Cond: **Sound**
